**Flood Control Project Maintenance  
Levee Inspections**

**Fall 2018 Levee Maintenance Deficiency Summary Report**

**Sacramento River Basin**

**Sutter Maintenance Yard Maintenance Area 0012**

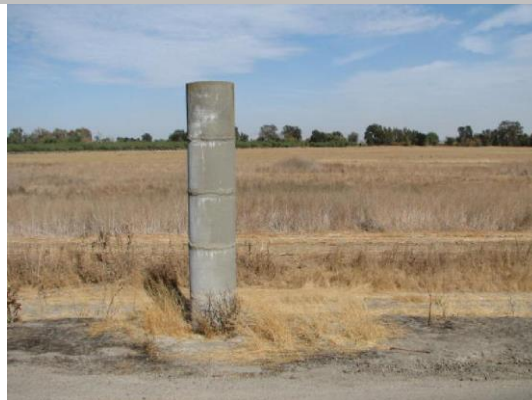
Photo 1 of 1 : UCIP\_FA\_2018\_51778\_68970.jpg

Comment Code					
Inspector Comment					
FS_ID:51778 DS_ID:17145 EP_NO: 9381 Repair Type: Non-Urgent Crossing Status: Indicator Found UCIP Comments: 5/2/2017 Abandoned- needs to be done so properly. Only the LS standpipe was found. (DWR Sutter Yard-AFreitag)10/17/2016 Abandoned (DWR Sutter Yard-AFreitag)5/31/2016 Abandoned- only the LS concrete standpipe was found.5/4/2015 Abandoned crossing.6/17/2014 Same as last inspection.12/16/2013 Same as last inspection.7/16/2013 Same as last inspection.10/11/2012 Need to verify proper abandonment of pipe. FIELD_STRUCT_DESC: *ABANDONED* 14-inch steel irrigation pipe through the levee, 3 feet below the crown. Open on the waterside (WS) end. 3-foot by 6-foot concrete well on the WS berm. Siphon breaker in 24-inch riser located on the landside (LS) shoulder. 36-inch concrete standpipe on the LS toe. The only item identified is the 36-inch standpipe on the LS toe. (Automatic Board Order (ABO) issued as Permit No. 9381, 1974 - F. L. Tribble). [Additional Reference(s): DWR Levee Log, 2005. USACE Sacramento O&M Manual 132, October 1959, (HLM 0.22, Drawing No. 50-4-3081)]. FS Date: 5/2/2017 1:37:36 PM

36-inch concrete riser on LS toe.

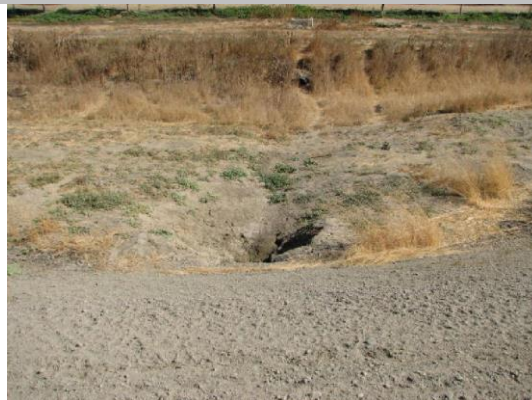
Photo 1 of 3 : UCIP\_FA\_2018\_51779\_68973.jpg

UCIP Comments: 5/2/2017 WS is in good condition. LS inlet is more than 50% full of sediment. Pipe needs to be cleaned internally. (DWR Sutter Yard- AFreitag)10/17/2016 MInor sediment blocking the WS flap gate from opening. LS inlet still mostly full of sediment.(DWR Sutter Yard- AFreitag)9/29/2016 Crossing has been downgraded from Urgent to Non-Urgent WS flap gate is closed for flood season. Need to coordinate with owner to remove sediment blocking WS flap gate. (DWR UCIP - omagana)5/31/2016 WS flap gate is blocked from opening by sediment. LS inlet is over 50% full of sediment. (DWR Sutter Yard - afreitag)5/4/2015 WS flap gate is blocked by sediment and unable to open. LS inlet is about 50% plugged with soil. Needs to be cleaned. (DWR Sutter Yard - afreitag)6/17/2014 Same as last inspection. (DWR Sutter Yard - afreitag)12/16/2013 Sediment against flapgate has been cleared and it can now function properly. (DWR Sutter Yard - afreitag)7/16/2013 Sediment is built up against WS flapgate preventing it from opening. (DWR Sutter Yard - afreitag)10/11/2012 Pipe is partially filled with soil. (DWR UCIP - wwylie)

Intake at LS toe.

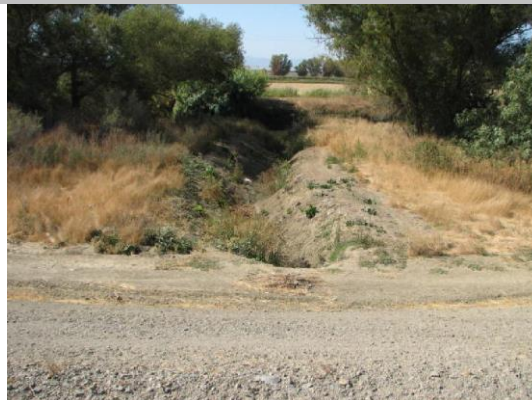
Photo 2 of 3 : UCIP\_FA\_2018\_51779\_68972.jpg

UCIP Comments: 5/2/2017 WS is in good condition. LS inlet is more than 50% full of sediment. Pipe needs to be cleaned internally. (DWR Sutter Yard- AFreitag)10/17/2016 MInor sediment blocking the WS flap gate from opening. LS inlet still mostly full of sediment.(DWR Sutter Yard- AFreitag)9/29/2016 Crossing has been downgraded from Urgent to Non-Urgent WS flap gate is closed for flood season. Need to coordinate with owner to remove sediment blocking WS flap gate. (DWR UCIP - omagana)5/31/2016 WS flap gate is blocked from opening by sediment. LS inlet is over 50% full of sediment. (DWR Sutter Yard - afreitag)5/4/2015 WS flap gate is blocked by sediment and unable to open. LS inlet is about 50% plugged with soil. Needs to be cleaned. (DWR Sutter Yard - afreitag)6/17/2014 Same as last inspection. (DWR Sutter Yard - afreitag)12/16/2013 Sediment against flapgate has been cleared and it can now function properly. (DWR Sutter Yard - afreitag)7/16/2013 Sediment is built up against WS flapgate preventing it from opening. (DWR Sutter Yard - afreitag)10/11/2012 Pipe is partially filled with soil. (DWR UCIP - wwylie)

Outlet at WS toe.

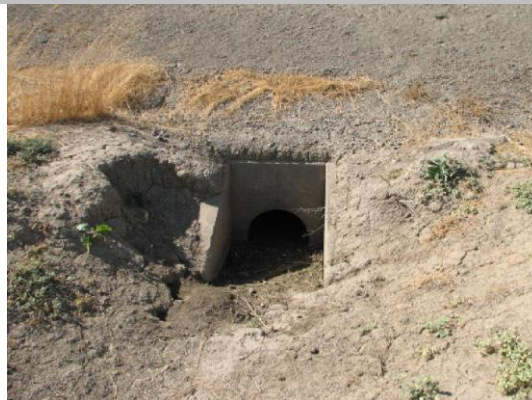
Photo 3 of 3 : UCIP\_FA\_2018\_51779\_68971.jpg

UCIP Comments: 5/2/2017 WS is in good condition. LS inlet is more than 50% full of sediment. Pipe needs to be cleaned internally. (DWR Sutter Yard- AFreitag)10/17/2016 Minor sediment blocking the WS flap gate from opening. LS inlet still mostly full of sediment.(DWR Sutter Yard- AFreitag)9/29/2016 Crossing has been downgraded from Urgent to Non-Urgent WS flap gate is closed for flood season. Need to coordinate with owner to remove sediment blocking WS flap gate. (DWR UCIP - omagana)5/31/2016 WS flap gate is blocked from opening by sediment. LS inlet is over 50% full of sediment. (DWR Sutter Yard - afreitag)5/4/2015 WS flap gate is blocked by sediment and unable to open. LS inlet is about 50% plugged with soil. Needs to be cleaned. (DWR Sutter Yard - afreitag)6/17/2014 Same as last inspection. (DWR Sutter Yard - afreitag)12/16/2013 Sediment against flapgate has been cleared and it can now function properly. (DWR Sutter Yard - afreitag)7/16/2013 Sediment is built up against WS flapgate preventing it from opening. (DWR Sutter Yard - afreitag)10/11/2012 Pipe is partially filled with soil. (DWR UCIP - wwylie)

Inlet and concrete headwall on LS toe.

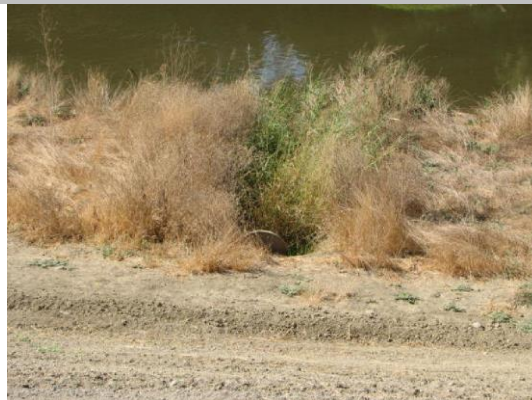
Photo 1 of 3 : UCIP\_FA\_2018\_51782\_68984.jpg

FS\_ID:51782  
DS\_ID:17149  
EP\_NO: 9382  
Repair Type: Non-Urgent  
Crossing Status: Found  
UCIP Comments: 5/2/2017 WS flapgate buried by sediment. Needs to be dug out. (DWR Sutter Yard- AFreitag)10/17/2016 Crossing appears to be in good condition. This is a gravity drain for the LS. (DWR Sutter Yard- AFreitag)5/31/2016 LS inlets was partially plugged. WS flapgate was clear of sediment and able to operate properly.5/4/2015 WS flapgate is blocked by sediment and unable to open. LS inlet is plugged by silt and wood chippings. Needs to be cleaned.6/17/2014 Flap gate was cleaned out and is fully closed. LS inlet still partially full of soil.12/16/2013 Same as last inspection. WS flapgate still needs to be cleaned out and shut.7/16/2013 Same as last inspection. Make sure flapgate is closed before highwater season.10/11/2012 Inlet on LS filled partially with soil. Outlet blocked with soil and the flap gate wont close.

Outlet on WS toe.

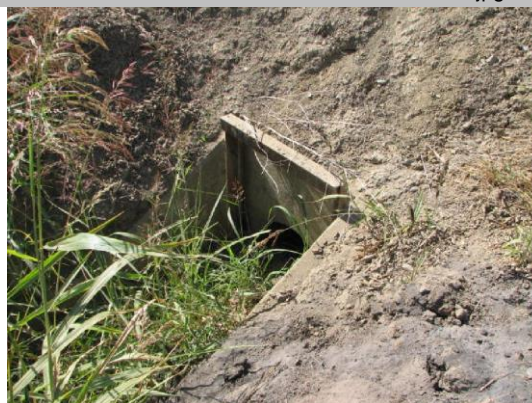
Photo 3 of 3 : UCIP\_FA\_2018\_51782\_68982.jpg

Comment Code						
Inspector Comment						
FS_ID:51782 DS_ID:17149 EP_NO: 9382 Repair Type: Non-Urgent Crossing Status: Found UCIP Comments: 5/2/2017 WS flapgate buried by sediment. Needs to be dug out. (DWR Sutter Yard- AFreitag)10/17/2016 Crossing appears to be in good condition. This is a gravity drain for the LS. (DWR Sutter Yard- AFreitag)5/31/2016 LS inlets was partially plugged. WS flapgate was clear of sediment and abale to operate properly.5/4/2015 WS flapgate is blocked by sediment and unable to open. LS inlet is plugged by silt and wood chippings. Needs to be cleaned.6/17/2014 Flap gate was cleaned out and is fully closed. LS inlet still partially full of soil.12/16/2013 Same as last inspection. WS flapgate still needs to be cleaned out and shut.7/16/2013 Same as last inspection. Make sure flapgate is closed before highwater season.10/11/2012 Inlet on LS filled partially with soil. Outlet blocked with soil and the flap gate wont close. FIELD_STRUCT_DESC: 24-inch corrugated metal drainage pipe through the levee, 13 feet below the crown. Flap gate, concrete headwall, and grouted cobble spillway on the waterside (WS). Concrete headwall on the landside (LS). (24-inch pipe [HLM 1.72] authorized under Automatic Board Order (ABO) issued as Permit No. 9382, 1974 - Olen C. Bober). [Additional Reference(s): DWR Levee Log, 2005. USACE Sacramento O&M Manual 132, October 1959, (HLM 1.72)]. FS Date: 5/2/2017 1:50:52 PM

Concrete U shaped headwall at LS inlet.

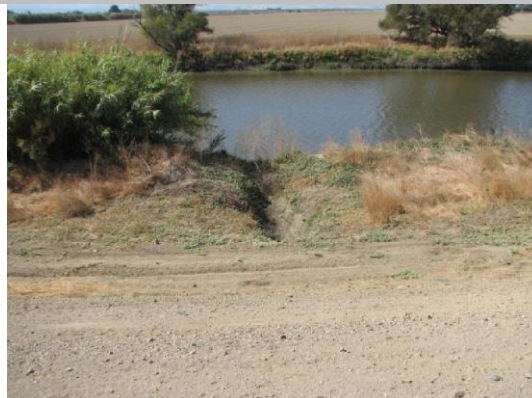
Photo 1 of 3 : UCIP\_FA\_2018\_51786\_68994.jpg

Comment Code						
Inspector Comment						
FS_ID:51786 DS_ID:17151 EP_NO: 9391 Repair Type: Non-Urgent Crossing Status: Found UCIP Comments: 5/2/2017 Both ends of pipe buried. (DWR Sutter Yard- AFreitag)10/17/2016 Appears abandoned. Both pipe ends are completely buried. (DWR Sutter Yard- AFreitag)9/29/2016 Crossing has been downgraded from Urgent to Non-Urgent both pipe ends are buried. Having both ends buried prevents water from flowing from WS to LS during flood season. Need to contact owner and have owner coordinate with CVFPB to comply with Title 23. (DWR UCIP - omagana)5/31/2016 Both pipe ends are buried. Pipe is non-operational. (DWR Sutter Yard - afreitag)5/4/2015 LS and WS ends are blocked with soil. Pipe is inoperable as it is. (DWR Sutter Yard - afreitag)6/17/2014 Same as last inspection. (DWR Sutter Yard - afreitag)12/16/2013 Same as last inspection. (DWR Sutter Yard - afreitag)7/16/2013 LS inlet is completely filled with soil. Needs to be cleaned out. (DWR Sutter Yard - afreitag)10/11/2012 Inlet is partially filled with soil. (DWR Sutter Yard - wwylie) FIELD_STRUCT_DESC: *ABANDONED* 24-inch corrugated metal drainage pipe through the levee, 13 feet below the crown. Flap gate, concrete headwall, and grouted cobble spillway on the waterside (WS). Concrete headwall on the landside (LS). (24-inch pipe authorized under Automatic Board Order (ABO) issued as Permit No. 9391, 1974 - Department of Water Resources, Northern District). [Additional Reference(s): DWR Levee Log, 2005. USACE Sacramento O&M Manual 132, October 1959, (HLM 2.02)]. FS Date: 5/2/2017 2:01:25 PM

WS view of outlet.

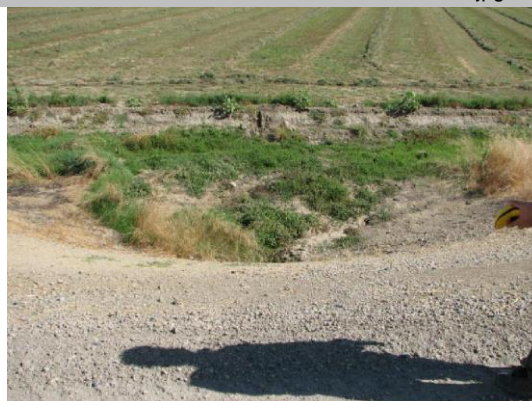
Photo 2 of 3 : UCIP\_FA\_2018\_51786\_68993.jpg

Comment Code						
Inspector Comment						
FS_ID:51786 DS_ID:17151 EP_NO: 9391 Repair Type: Non-Urgent Crossing Status: Found UCIP Comments: 5/2/2017 Both ends of pipe buried. (DWR Sutter Yard- AFreitag)10/17/2016 Appears abandoned. Both pipe ends are completely buried. (DWR Sutter Yard- AFreitag)9/29/2016 Crossing has been downgraded from Urgent to Non-Urgent both pipe ends are buried. Having both ends buried prevents water from flowing from WS to LS during flood season. Need to contact owner and have owner coordinate with CVFPB to comply with Title 23. (DWR UCIP - omagana)5/31/2016 Both pipe ends are buried. Pipe is non-operational. (DWR Sutter Yard - afreitag)5/4/2015 LS and WS ends are blocked with soil. Pipe is inoperable as it is. (DWR Sutter Yard - afreitag)6/17/2014 Same as last inspection. (DWR Sutter Yard - afreitag)12/16/2013 Same as last inspection. (DWR Sutter Yard - afreitag)7/16/2013 LS inlet is completely filled with soil. Needs to be cleaned out. (DWR Sutter Yard - afreitag)10/11/2012 Inlet is partially filled with soil. (DWR Sutter Yard - wwylie) FIELD_STRUCT_DESC: *ABANDONED* 24-inch corrugated metal drainage pipe through the levee, 13 feet below the crown. Flap gate, concrete headwall, and grouted cobble spillway on the waterside (WS). Concrete headwall on the landside (LS). (24-inch pipe authorized under Automatic Board Order (ABO) issued as Permit No. 9391, 1974 - Department of Water Resources, Northern District). [Additional Reference(s): DWR Levee Log, 2005. USACE Sacramento O&M Manual 132, October 1959, (HLM 2.02)]. FS Date: 5/2/2017 2:01:25 PM

LS view of inlet.

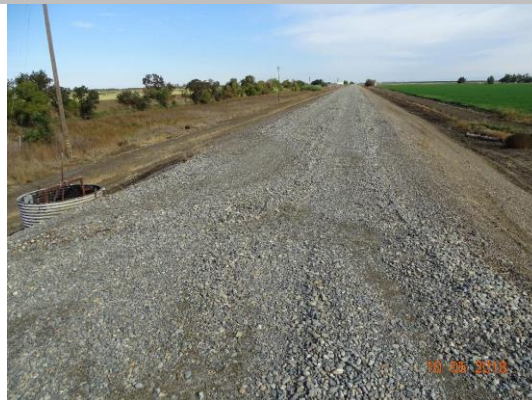
Photo 1 of 3 : UCIP\_FA\_2018\_53011\_78198.jpg

FS\_ID:53011  
DS\_ID:17154  
EP\_NO: 9388  
Repair Type: Non-Urgent  
Crossing Status: Found  
UCIP Comments: 10/5/2018 Fall hazard: missing cover on CMP riser. Closure devices are present on both ends of crossing and seem to be in operable condition. Downgraded to non-urgent. Recommend owner add cover to CMP riser. (O.Yakimov - DWR)5/2/2017 WS slidegate stem is still bent, wheel to operate gate is missing. Needs a cover made for the standpipe to prevent falls. (DWR Sutter Yard- AFreitag)10/17/2016 Slide gate stem is still and the gate appears to be inoperable. (DWR Sutter Yard- AFreitag)5/31/2016 Slide gate stem is still bent. WS flap gate is chained open. (DWR Sutter Yard - afreitag)5/4/2015 Slide gate stem is still bent. Gate looks to be unable to close all the way. (DWR Sutter Yard - afreitag)6/17/2014 Same as last inspection. (DWR Sutter Yard - afreitag)12/16/2013 Slide gate stem is still bent. WS flapgate was closed. (DWR Sutter Yard - afreitag)7/16/2013 Water flowing through pipe so screw gate definitely not closed. Was told NOV's have been sent for owner to replace stem. Flap gate gets closed for flood season. (DWR Sutter Yard - afreitag)10/11/2012 Slide gate inoperable, but appears to be in closed position. Flap gate held in open position. Good candidate for video inspection when, if ever, dry. (DWR UCIP - wwyllie)

View of levee crown at crossing.

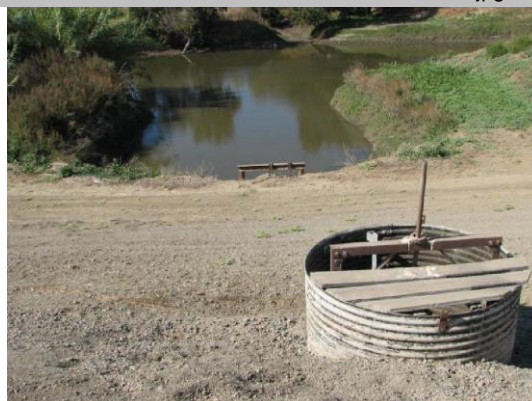
Photo 2 of 3 : UCIP\_FA\_2018\_53011\_69005.jpg

Comment Code						
Inspector Comment						
FS_ID:53011 DS_ID:17154 EP_NO: 9388 Repair Type: Non-Urgent Crossing Status: Found UCIP Comments: 10/5/2018 Fall hazard: missing cover on CMP riser. Closure devices are present on both ends of crossing and seem to be in operable condition. Downgraded to non-urgent. Recommend owner add cover to CMP riser. (O.Yakimov - DWR)5/2/2017 WS slidegate stem is still bent, wheel tto operate gate is missing. Needs a cover made for the standpipe to prevent falls. (DWR Sutter Yard- AFreitag)10/17/2016 Slide gate stem is still and and the gate appears to be inoperable. (DWR Sutter Yard- AFreitag)5/31/2016 SLide gate stem is still bent. WS flap gate is chained open. (DWR Sutter Yard - afreitag)5/4/2015 Slide gate stem is still bent. Gate looks to be unable to close all the way. (DWR Sutter Yard - afreitag)6/17/2014 Same as last inspection. (DWR Sutter Yard - afreitag)12/16/2013 Slide gate stem is still bent. WS flapgate was closed. (DWR Sutter Yard - afreitag)7/16/2013 Water flowing through pipe so screw gate definitely not closed. Was told NOV's have been sent for owner to replace stem. Flap gate gets closed for flood season. (DWR Sutter Yard - afreitag)10/11/2012 Slide gate inoperable, but appears to be in closed position. Flap gate held in open position. Good candidate for video inspection when, if ever, dry. (DWR UCIP - wwyllie) FIELD_STRUCT_DESC: 48-inch corrugated metal drainage pipe through the levee, 28 feet below the crown. Slide gate in a 66-inch riser on the waterside (WS) slope. Concrete headwall on the WS. Grouted cobble spillway from drainage ditch to large canal on the landside (LS). (48-inch pipe [HLM 3.78] authorized under Automatic Board Order (ABO) issued as Permit No. 9388, 1974 - Pauline A. Wallace). [Additional Reference(s): DWR Levee Log, 2005. USACE Sacramento O&M Manual 132, October 1959, (HLM 3.78)]. FS Date: 10/5/2018 2:47:50 PM

Slide gate in corrugated metal riser on WS slope.

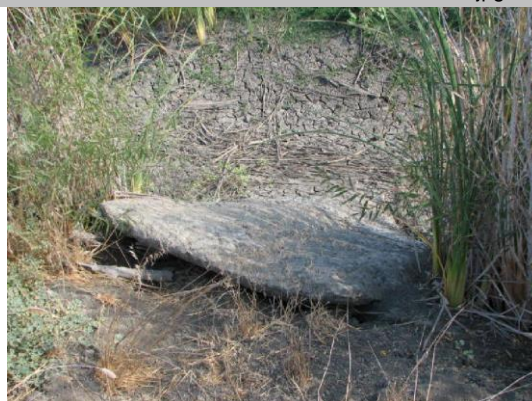
Photo 1 of 3 : UCIP\_FA\_2018\_51796\_69030.jpg

Apparent inlet clogged with concrete or grout on LS toe in drainage swale.

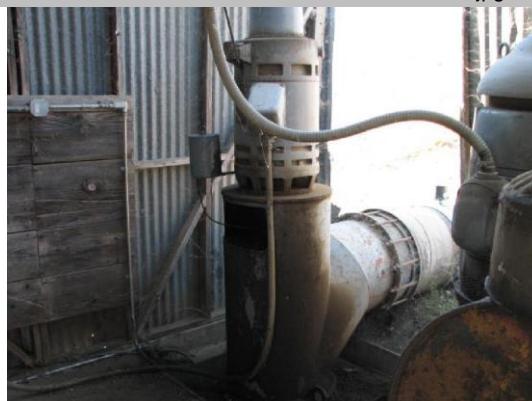
Photo 3 of 3 : UCIP\_FA\_2018\_51800\_69059.jpg

Pump with oil leakage shown on side of pipe.

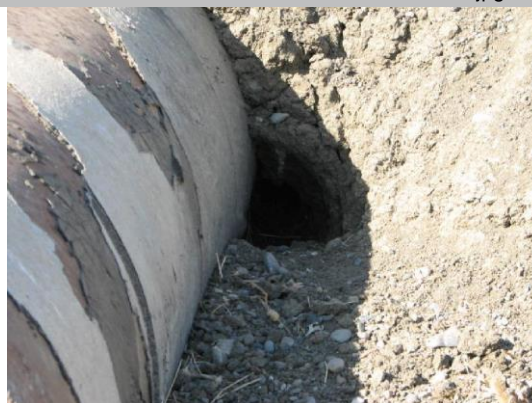
Photo 3 of 3 : UCIP\_FA\_2018\_51804\_69087.jpg

Animal burrows along side of pipe LS.

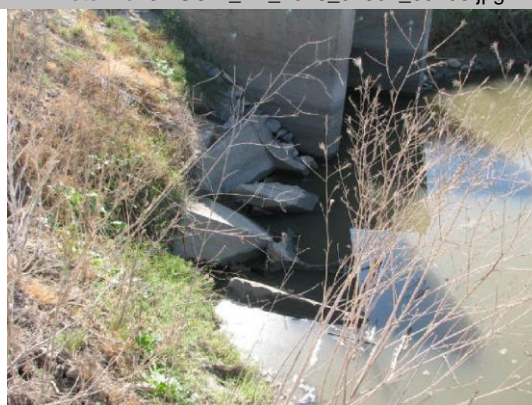
Photo 2 of 3 : UCIP\_FA\_2018\_51807\_69108.jpg

headwall debris on LS toe showing evidence of 18-inch cmp.

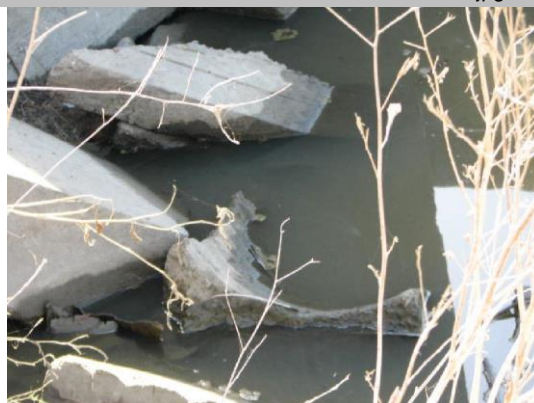
Photo 3 of 3 : UCIP\_FA\_2018\_51807\_69107.jpg

headwall debris on LS toe showing evidence of 18-inch cmp.

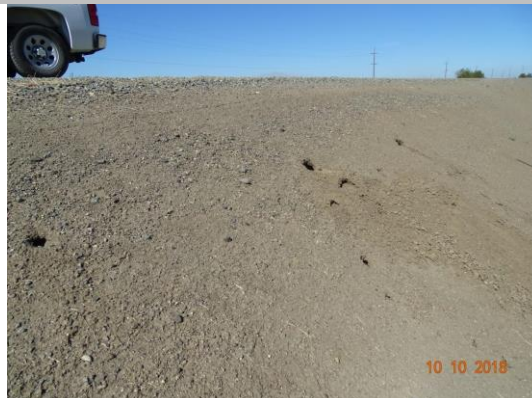
Photo 1 of 1 : FA\_2018\_MA0012\_299\_36\_20181011\_00085.jpg

View of rodent holes on the landside slope. Fall 2018.

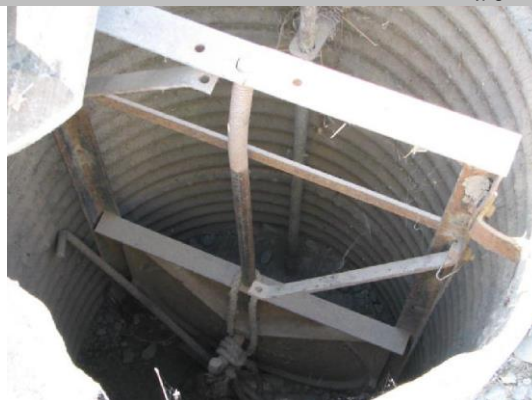
Photo 2 of 2 : UCIP\_FA\_2018\_51810\_69114.jpg

Bent and broken actuator on slide gate in 36-inch CMP. Pipe appears to be filled with soil.
